Monitoring Data Record

Project Title: R-2417BB (Site 6) COE Action ID: 200201326
 Stream Name: _____ DWQ Numbers: 3378
 City, County and other Location Information: Lee County, Sanford Bypass (Sta. 540+20 to 555+00 -L- RT.)
 Date Construction Completed: Water was turned into the stream in Oct. 2006. Streambank reforestation was completed in Jan. 2007.
 Monitoring Quarter: (1) of 8
 Ecoregion: _____ 8 digit HUC unit: 03030004
 USGS Quad Name and Coordinates: _____

Site 6

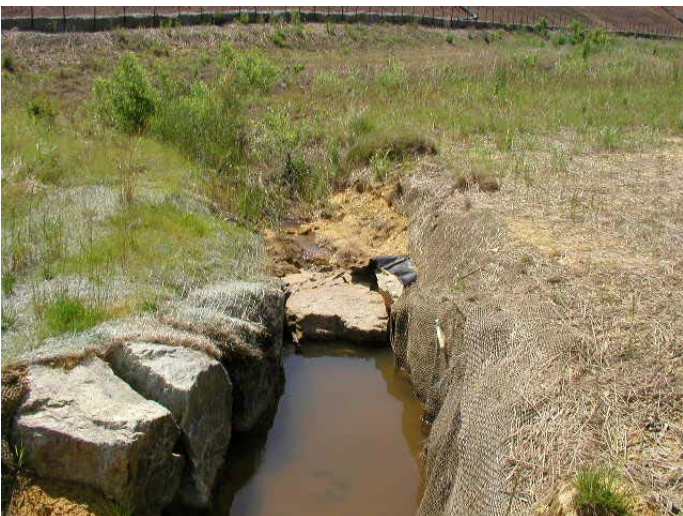
Photo Point #6 (Upstream)

5/21/07	PP #6 Upstream Sta. 546 +75	PP #7 Downstream Sta. 545+60	Station Number	Station Number	Station Number
Structure Type	Crossvane	Crossvane			
Is water piping through or around structure?	Water is piping through the crossvane	Water is piping through the crossvane			
Head cut or down cut present?	Slight headcut				
Bank or scour erosion present?					
Other problems noted?
